# What Temperature Can't Tell You: How Real-Time Wear Data Drives Better Furnace Decisions

Frederic Rougevin-Baville  
PaneraTech, Inc., United States

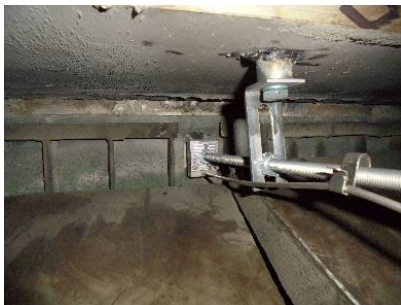
Sensor Network in Sidewall

Polaris™ at Sidewall
