GPC # Life Beneath Pavers, Operating Furnaces for Years after Glass Breaches

Mohit Gohel
PaneraTech, Inc., United States

Extending Furnace Life Through Early Detection & Data-Driven Action

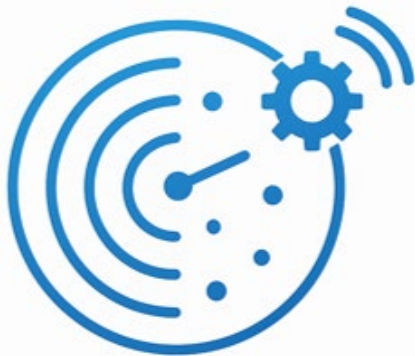
Radar detection spots refractory wear and glass penetration 2-3 years before temperature increases, enabling proactive cost-saving maintenance.

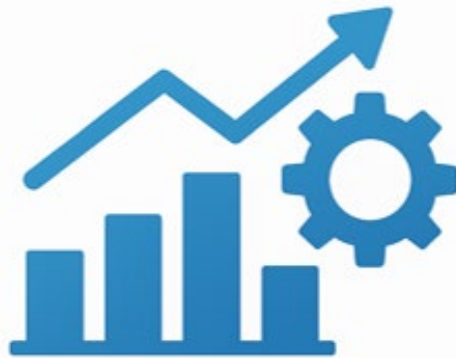
Polaris™ analytics outperform temperature readings, revealing true wear to optimize cooling, improve furnace operation and extend asset life.

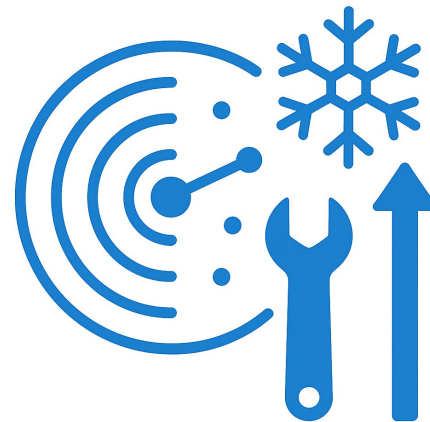
Data-driven actions - precise cooling and timely repairs - extend furnace life by 5 to 6 years even after glass has penetrated to the bottom insulation.

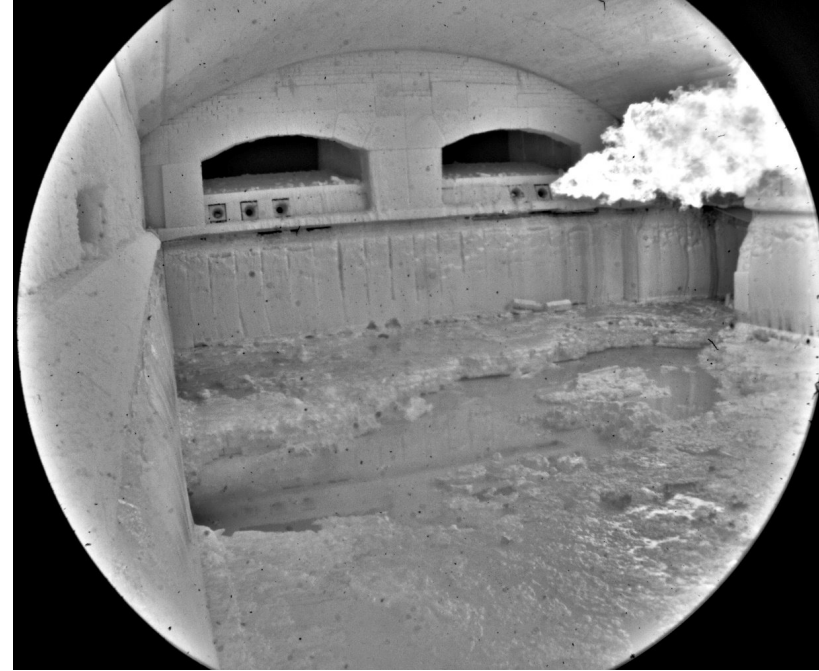
Glass Penetration Detection: Temperature Is a Late Indicator

Temperature disguised due to insulation layers

Relying on temperature = late-stage detection.

Radar detects issues 2-3 years earlier.

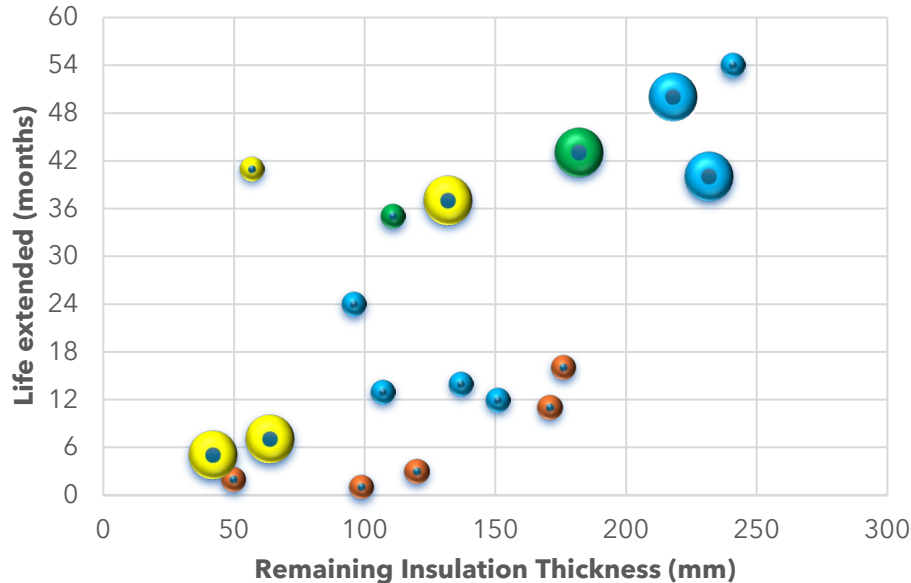
Extended Furnace Life & Clay flux remaining Thickness (Months & mm)

- Extensions of ≤ 5 months involved bottom issues and other operational concerns too.
- Large circles: Furnace is in operation currently.
- Small circles: Furnace shut down safely as per no. of months mentioned in chart.
- Different Colour Codes: Indicate maintenance type following glass infiltration into insulation.

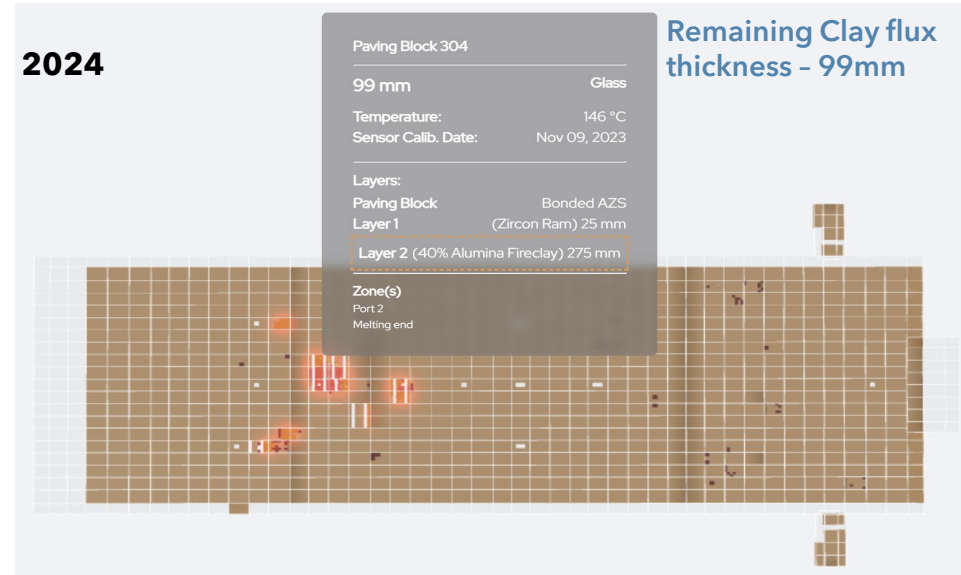
Asset Life Extension in a Float Bottom

Customer implemented grating support, applied air cooling, managed wear rates, and coordinated timely AZS chip repairs.

Furnace life was extended by nearly two years.

- Campaign Start Date: 2009
- 2019: Limited Scope of Bottom Inspection - No wear observed
- 2022: Wear identified in clay flux
- 2023 & 2024: Hot bottom AZS chip repairs with defined scope
- Regular Follow-ups: 7 Inspections from 2022 to 2024

Glass Into clay flux

2022

2024

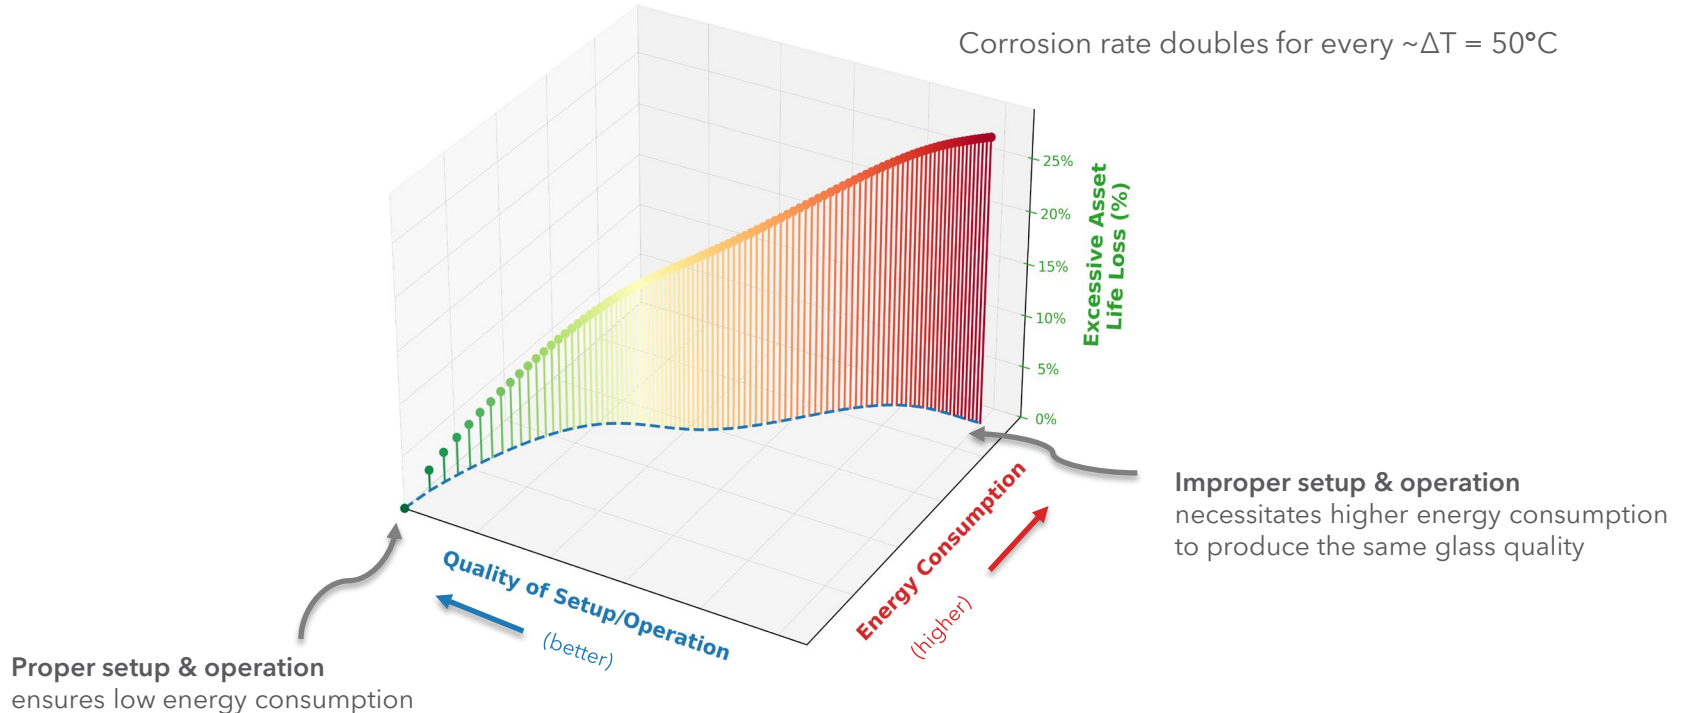
Asset life is frequently overlooked by engineers in day-to-day furnace operation.

Corrosion rate doubles for every $\sim \Delta T = 50^{\circ}\text{C}$

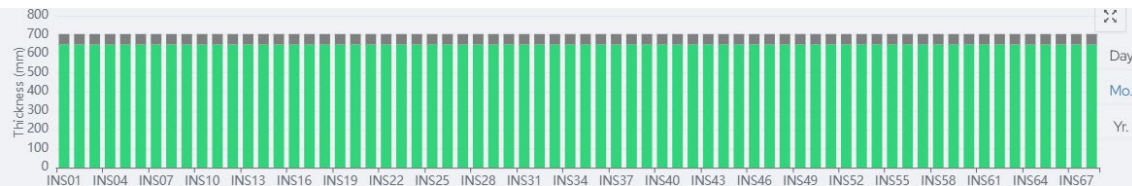
Online - Polaris™ Layout Examples & Disclaimer

Polaris™ IoT Refractory Sensor System: Permanent sensor provides continuous real-time radar monitoring of refractory thickness, deeper than portable sensors

Detects through ramming mix up to the cold face of the paving.

1. Real-time feedback on furnace operation impact on refractory life (e.g., metal infiltration, wear).
2. Deeper visibility due to continuous data
3. Wear rate can be tracked and compared with operational changes.
4. Coverage can be achieved 80 - 90% of the bottom.

Note: Red circle in bottom layout show Polaris coverage.

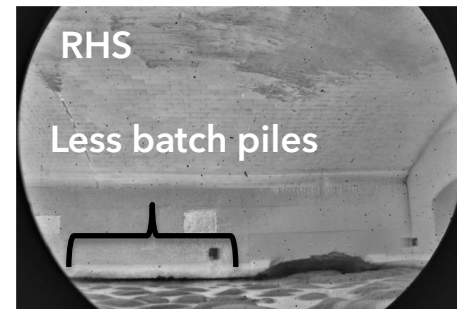
Leveraging Online Thickness Data: Uneven Wear

Moderate downstream and upstream **wear imbalance** discovered in Polaris™ data

Equal and **adequate** sidewall cooling on both sides was found

Batch piles found to be progressing far downstream and against left side, **causing higher wear**

Residual thickness mm

Current wear rates mm/month
